Environmental Site
Assessment
Related to UST Closure
at
Rice Lumber Company, Inc.
Route 7, Shelburne, VT
SMS Site #97-2320

BINKERD ENVIRONMENTAL - Project Number 97008

September 1998

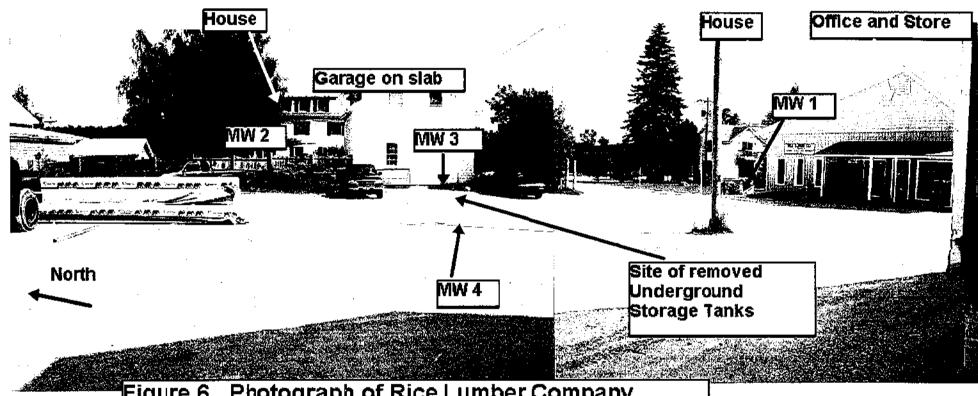
- the UST's did not leak as documented in the closure report;
- groundwater in MW-3 was the most impacted, but this well is two feet from the edge of the excavation and is not represented of groundwater quality down gradient of the site of the removed UST's. MW-4 is directly down gradient of the site of the removed UST's and groundwater at this location does not indicate levels of contamination above Groundwater Enforcement Standards or Vermont Health Advisory levels.
- a plausible means of contamination has been presented,
 i.e., by surface spills during filling the tanks and/or filling cars and trucks at the gas pumps.

Figure 6. Photograph of Rice Lumber Company looking toward the east depicting the locations of the Monitoring Wells (MW).

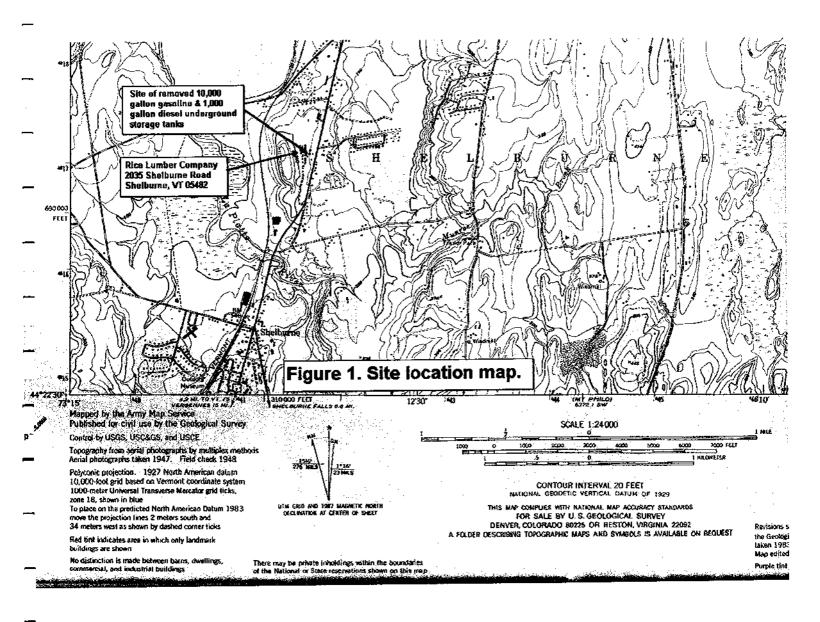
Due to water in the pit, a soil sample below the removed 10,000 gallon tank could not be obtained. There was no free product on top of the water in the pit. Based on the description of soil contamination in the closure report (Appendix A) the Sites Management Section (SMS) determined that the limits of soil contamination were defined (28 April 1998).

Figure 2. Excavated soils with PID readings and approximate locations of soil samples. All excuvated soils retuurned to hole with clean fill placed on top.

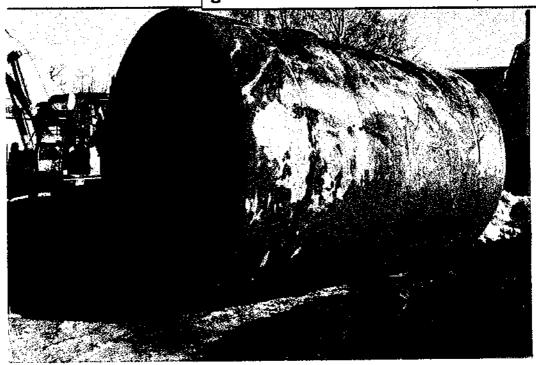
Upon removal both tanks were found to be in good to excellent condition. No rust, pitting, scaling or holes were identified on either tank. All associated piping was is good to excellent condition. Both tanks were reported by a Rice Lumber Company representative to be about eighteen years old. The large 10,000 gallon gasoline tank was located partially below the water table. Metal straps surrounded the tank and were connected to a concrete pad to hold the tank down. Once these straps were broken the nearly empty tank floated due to water in the pit.

10,000 gallon gasoline storage tank; good to excellent condition, no holes

Figure 3. Pitures showing condition of the removed underground storage tanks on 8 December 1997.
